## MVF / MERIVAARA France

**Dear user of Merivaara's Baby Crib Trolley 381**

30 May 2006

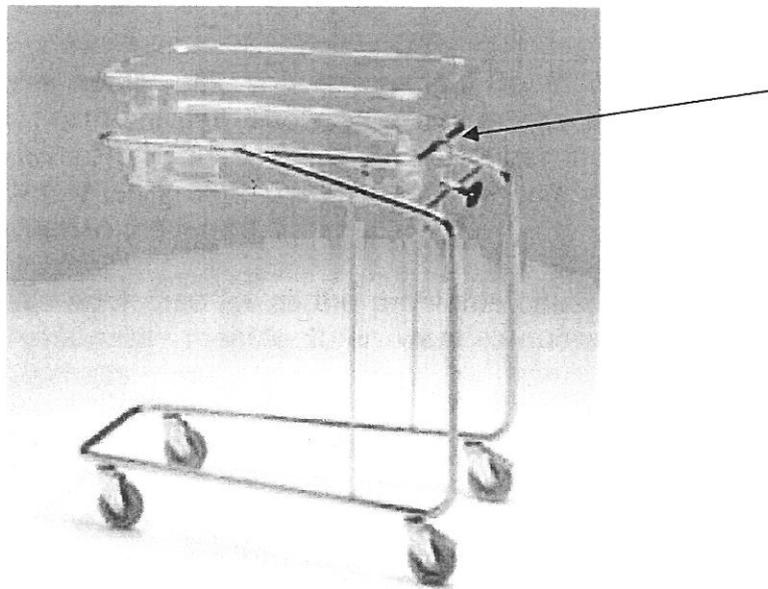
Le berceau de maternité. La flèche indique la barre de réglage & sa vis de blocage.

We have noticed, that in some of the Merivaara's Baby Crib Trolleys' tightening screw of the adjusting bar (trendelenburg and anti-trendelenburg adjustment) have experienced opening of the threads. The reason for opening is that screw is 2 mm too short. The length of the screw is 20 mm. Then it was possible that the screw was not tighten long enough into nylock-nut. If this defect is not fixed and product is in continuous use there might be a minor risk of endangering patient's safety.

**Picture 1** Baby Crib trolley. The arrow shows the adjusting bar and its tightening screw.

We kindly ask you to change Baby Crib Trolley's tightening screw of the adjustment bar. The new screw is attached to this letter. Please see enclosed picture 3. New screw is 2 mm longer than the old one. The length of the new screw is 22 mm. By changing the screw we make sure that the threads won't open in the future.

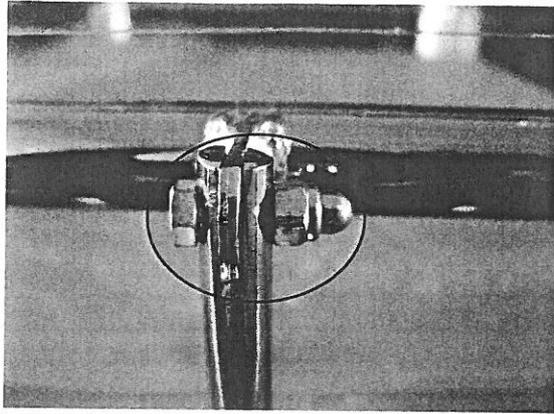
La Photo 2 présente la barre de réglage originale des berceaux livrés avant le 1<sup>er</sup> Mai 2003.

**Picture 2** shows the previous construction of adjustment bar (before 1 May 2003 delivered).
