## Information Urgente de sécurité

### Erreur de validation des données du système Intellis™ Mise à jour logicielle modèle A710 vers la version 1.3.130

Décembre 2020

Référence Medtronic : FA949

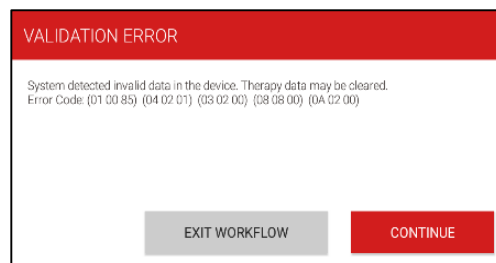
Ce problème apparaît et est reconnu dans l'environnement clinique lorsque le patient est suivi par un professionnel de santé. Si vous rencontrez « VALIDATION ERROR » (L'erreur de validation, comme indiquée ci-contre) avec le code d'erreur (01 00 85) (04 02 01) (03 02 00) (08 08 00) (0A 02 00) **avant** d'installer la dernière version de l'application logicielle Intellis A710, v1.3.130, veuillez sélectionner l'option « **CONTINUE** » (Continuer). Si « **EXIT WORKFLOW** » (Quitter flux de travail) est sélectionnée, veuillez rétablir la communication et sélectionner « **CONTINUE** » (Continuer) en présence de « VALIDATION ERROR » (L'erreur de validation) (figure 1).

Figure 1 : message indiquant l'erreur de validation

Veillez télécharger la dernière mise à jour de l'application logicielle Intellis A710, version 1.3.130, sur le programmeur médecin CT900 en respectant les instructions jointes.

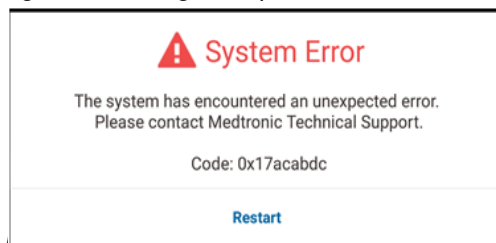
Après avoir sélectionné l'option « **CONTINUE** » (Continuer), si cette « **System Error** » (Erreur système) (Figure 2) s'affiche, veuillez

contacter votre représentant Medtronic pour obtenir de l'aide pour le téléchargement de la toute dernière application logicielle Intellis A710 v1.3.130. Après avoir téléchargé la toute dernière application logicielle Intellis v1.3.130, veuillez rétablir la communication et sélectionner « **CONTINUE** » (Continuer) pour corriger ce problème.
